# 2014 Asset Management Plan

Annual Planning Report

### Executive Summary

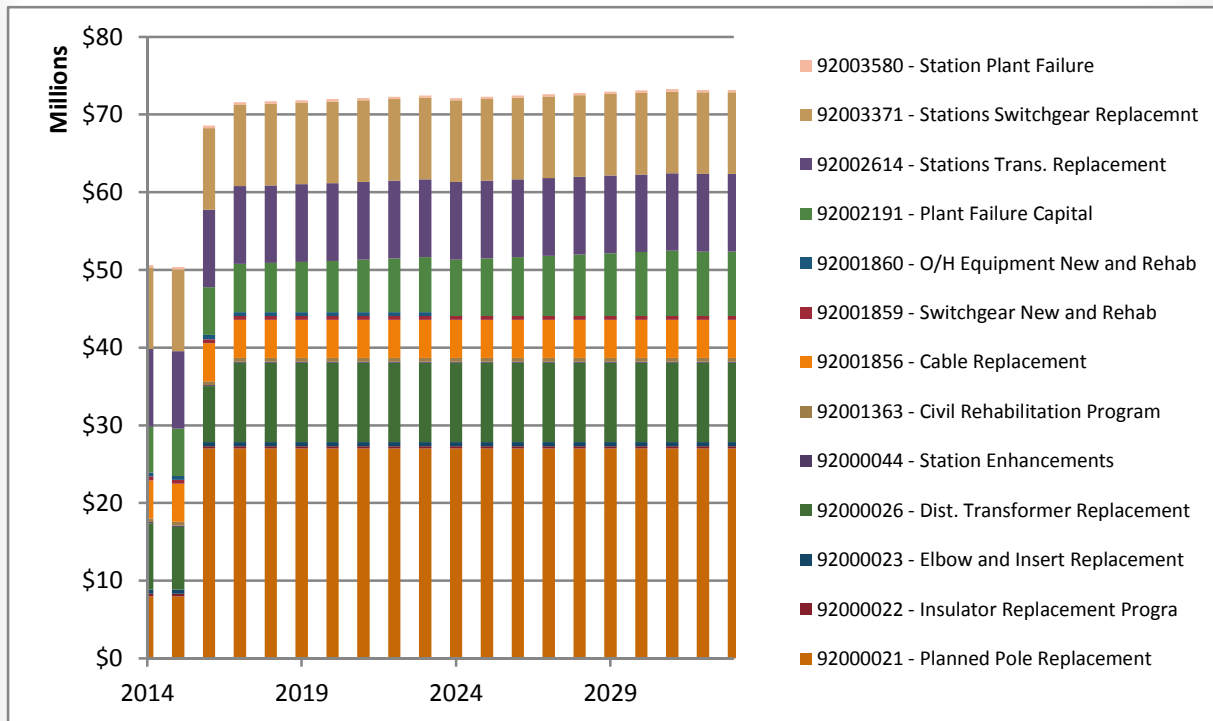
FIGURE 3.1 - FORECASTED ASSET REPLACEMENT NEEDS

Forecasted investment required to manage Hydro Ottawa’s distribution assets over the next 20 years is shown in Figure 3.1. Without these increases, average annual asset failure costs will continue to rise. These increased failures bring with them impacts to system reliability and worker & public safety as well as directly impacting failure costs and labour resourcing.

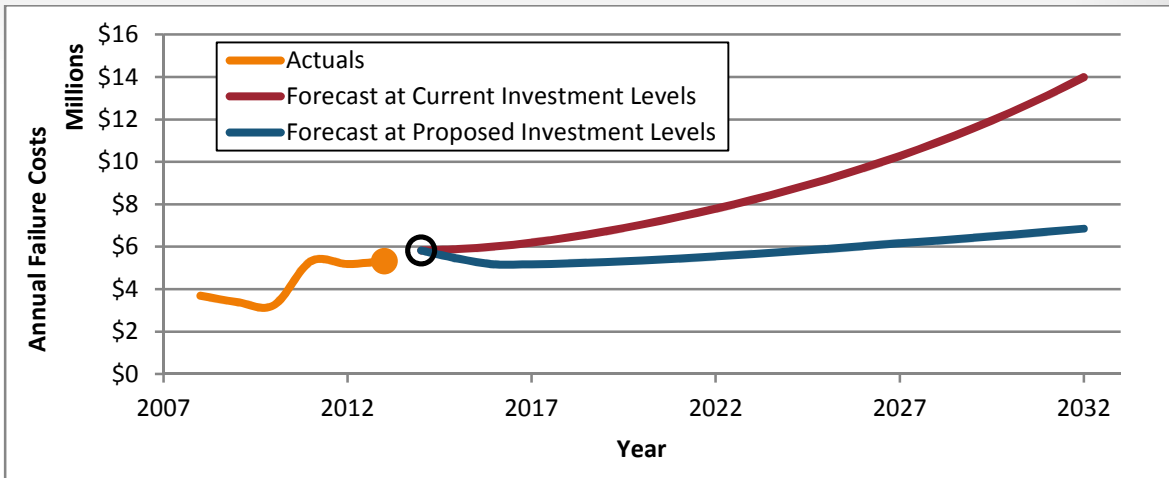
FIGURE 3.2 - FORECASTED ASSET FAILURE COSTS

The forecasted asset failure costs, distribution failure labour requirements, and system reliability impact at current and proposed investment levels are shown in Figure 3.2, Figure 3.3 & Figure 3.4, respectively.

These forecasts indicate that the expected annual average year to year failure rates and associated costs can and are expected to vary significantly. If the failure rates are allowed to continue to rise, the financial and labour impacts year-to-year will considerably impact the ability to manage financial performance and crew scheduling.

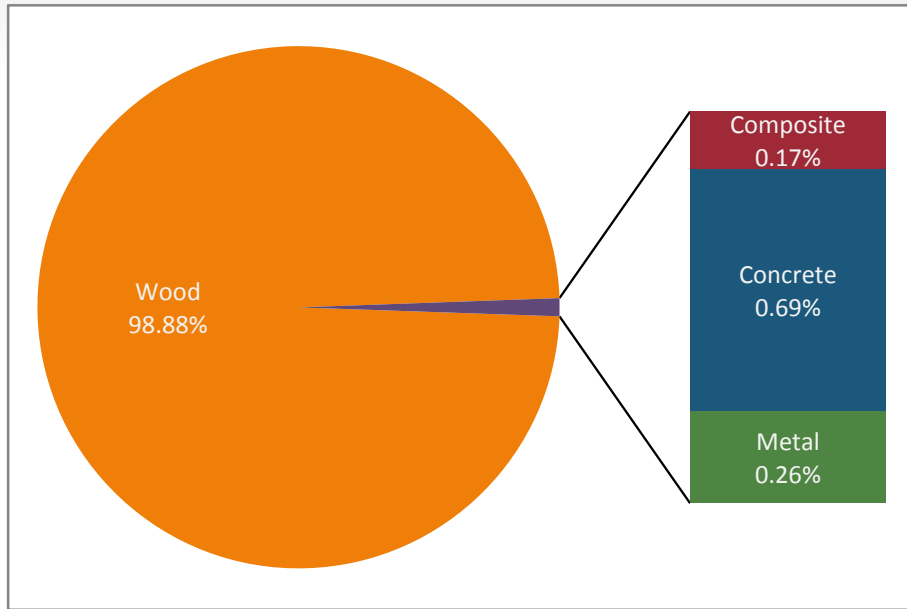
FIGURE 6.1 - DISTRIBUTION POLES BY MATERIAL (OWNED AND OPERATE ON)

Hydro Ottawa owns 47,815 wood poles and 537 non-wood poles and operate on an additional 11,635 wood and 126 non-wood poles which are owned by third parties. The proportions of these poles by material are shown graphically in Figure 6.1. Currently, Hydro Ottawa has installation date information for approximately 25% of its poles (41% of those operated on). Those poles for which installation information is not available, install data has been estimated using manufacture date, estimated from the adjacent property legal records, or assumed to be equivalent to the average age of the known poles in that region (roughly 41% of asset group).

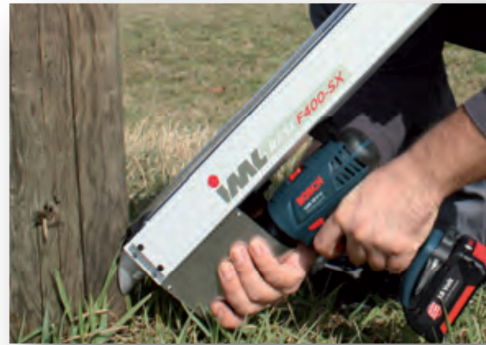
FIGURE 6.3 - IML RESISTOGRAPH DRILL

Hydro Ottawa initiated a combined program of visual inspection and non-destructive testing in 2010. This program utilizes Resistograph drills for the detection and measurement of internal decay and measurement

of the remaining shell thickness with minimal damage to the pole. Visual inspection is conducted on all poles in a section of overhead line, and approximately 20% of the poles in each pole line are tested using the Resistograph drill, the results of which can be extrapolated to all poles within the section, or poles of similar vintage. The management of distribution poles is driven by the results of this ongoing inspection program.

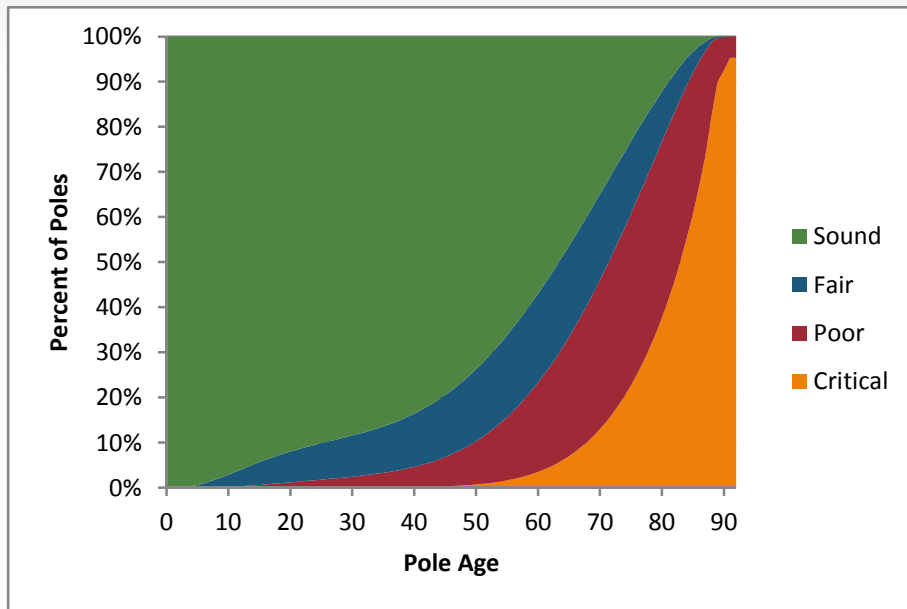
FIGURE 6.5 - PROPORTION OF WOOD POLE CONDITION BY AGE

In the past, analysis has correlated the pole to failures to develop a hazard curve and estimate the probability of failure at any given age. With the increased availability of inspection data for the distribution poles, current analysis has been carried out to correlate the remaining strength to pole age. The remaining strength to pole age correlation will become more accurate as more inspection data is collected every year. Based on this analysis, poles have been grouped into 4 categories as shown in Table 6.1. The resulting pole distribution based on this model can be seen in Figure 6.5.

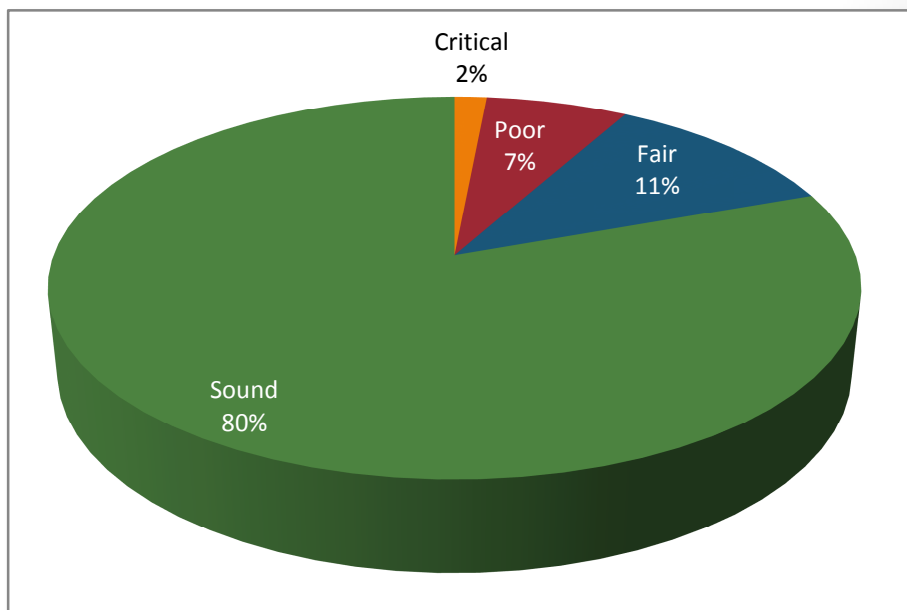
FIGURE 6.6 - ESTIMATED CONDITION OF WOOD POLE ASSETS

By extrapolating this model to the entire asset class it is estimated that 9% (4,945) of the wood poles which Hydro Ottawa owns or operates on are currently below 60% remaining strength and require replacement.

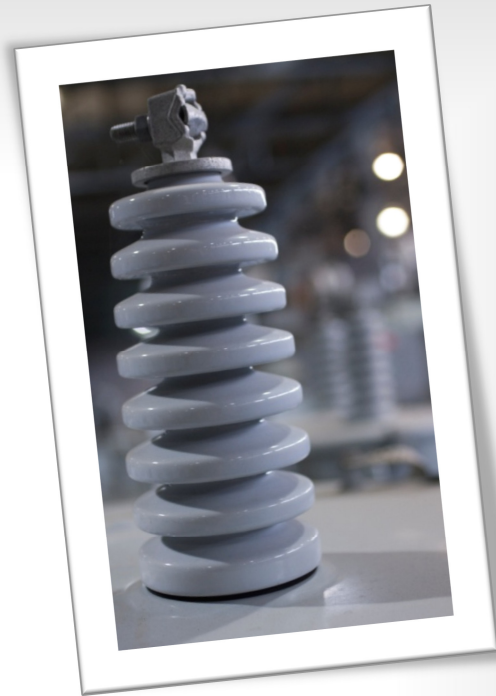
**FIGURE 6.10 -PERCENTAGES OF INSPECTED POLES WITH PROBLEM TYPE INSULATORS**

Limited information is available on the locations of these insulators. At this time, funding for planned and ad hoc replacement should be maintained. In addition, information regarding location and quantity of the problem insulator types is beginning to be collected as part of the pole inspection program. Figure 6.10 below

shows a map of the areas that have undergone pole inspection and the associated percentage of poles inspected that contain problem type insulators.

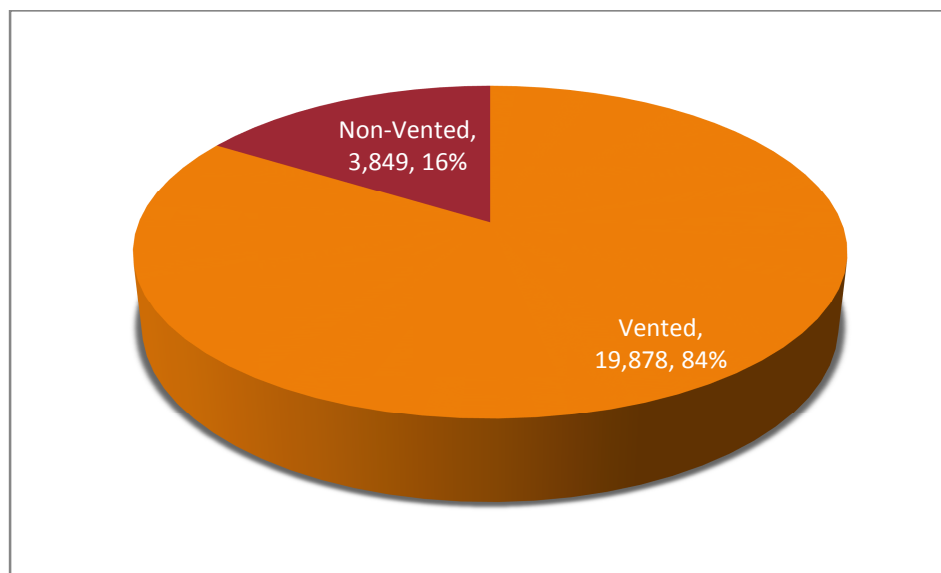
FIGURE 6.11 - 27.6 kV ELBOW DEMOGRAPHICS

There are two categories of elbows: vented and non-vented, which equates to having the ability for full switching capabilities or restricted switching, strictly on the 27.6kV system. On the 27.6kV system, the non-vented elbow design has led to flashes, due to the creation of a vacuum at below freezing temperatures as the field crew separates the elbow from the bushing under load (live). Due to this, the elbows and inserts that cannot be separated while the circuit is energized must be identified as non-vented. The flash is a safety risk to employees and will typically cause a local outage. Figure 6.11 shows the proportion of non-vented elbows remaining on the 27.6 kV system, this data is taken from HOL's Geographical Information system (GIS).

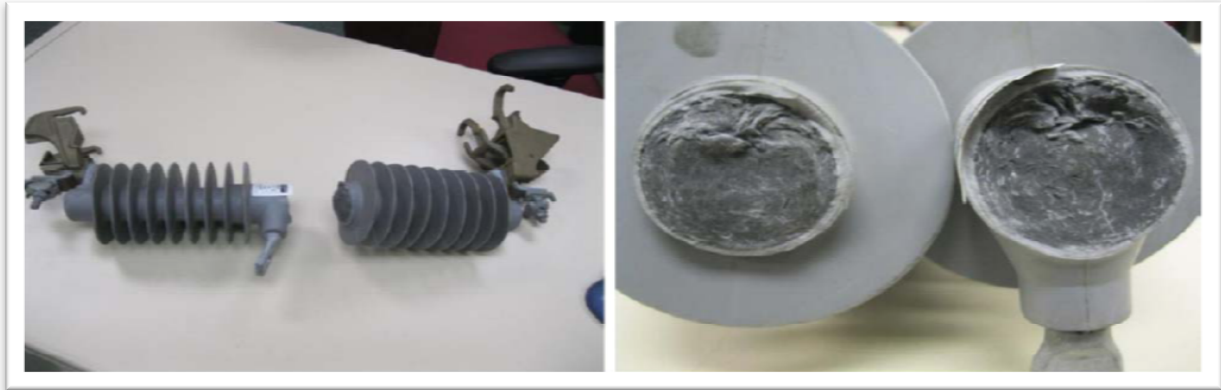
FIGURE 6.34 - FAILED S& C SMD-20 SWITCH

In 2011, S&C Electric Canada informed Hydro Ottawa that there have been a number of failures reported by various utilities across Canada of polymer 28kV SMD-20 switches manufactured between 2004 and 2011. S&C's investigation has determined that the 28kV SMD-20 switch failures occurred when the switches were

operated using a load break tool. An example of a failed switch can be seen in Figure 6.34. Hydro Ottawa has approximately 2,800 of both the S&C polymer and old porcelain 28kV SMD-20 switches deployed in the system.
