# 1755 FROBISHER LANE OTTAWA

BUILDING RETROFIT ROADMAP  
PREPARED FOR MINTO APARTMENT LIMITED PARTNERSHIP  
DECEMBER 21, 2020

# EXECUTIVE SUMMARY

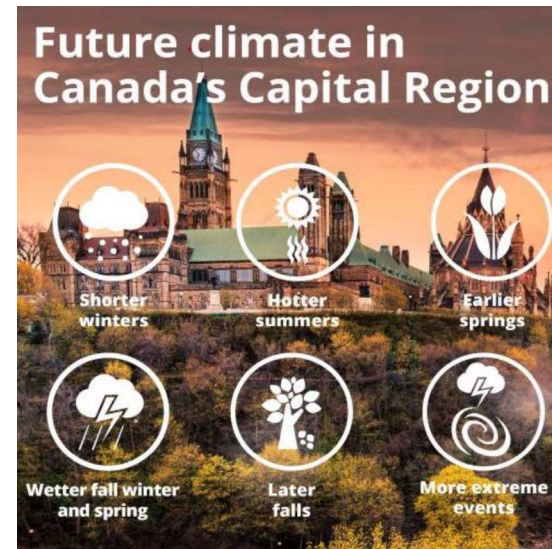
The projected climate for Ottawa over the next few decades is summarized in the Figure on the right. Extreme weather can manifest as intensified wind speeds and severe precipitation downbursts leading to flood risks and ice storms. Existing buildings must be able to effectively manage current and future environmental loads.

SOURCE: CLIMATE PROJECTIONS FOR THE NATIONAL CAPITAL REGION (2020)

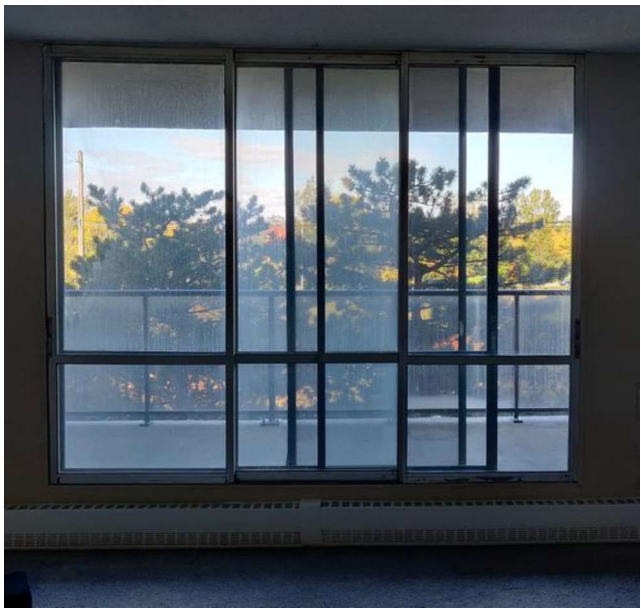
The building at 1755 Frobisher Lane, known as Castlevue, is 26-storeys with 242 units and a gross leasable area of 171,000 sq. ft. The building was built in the early 1970s and has not undergone any major retrofits to the building enclosure. The building is primarily clad with precast wall panels and single pane aluminum glazing systems. The primary roof system is a conventional exposed roof assembly. Each suite has access to a private cantilevered concrete balcony, shown in the figure below.

IMAGE OF SUITE WINDOW AND BALCONY FROM RDH SITE VISIT
